FINAL REPORT  
OF  
PERFORMANCE OF EXPERIMENTAL  
BRIDGE APPROACH SLABS  
IN  
DISTRICT 07

67-63

April, 1967

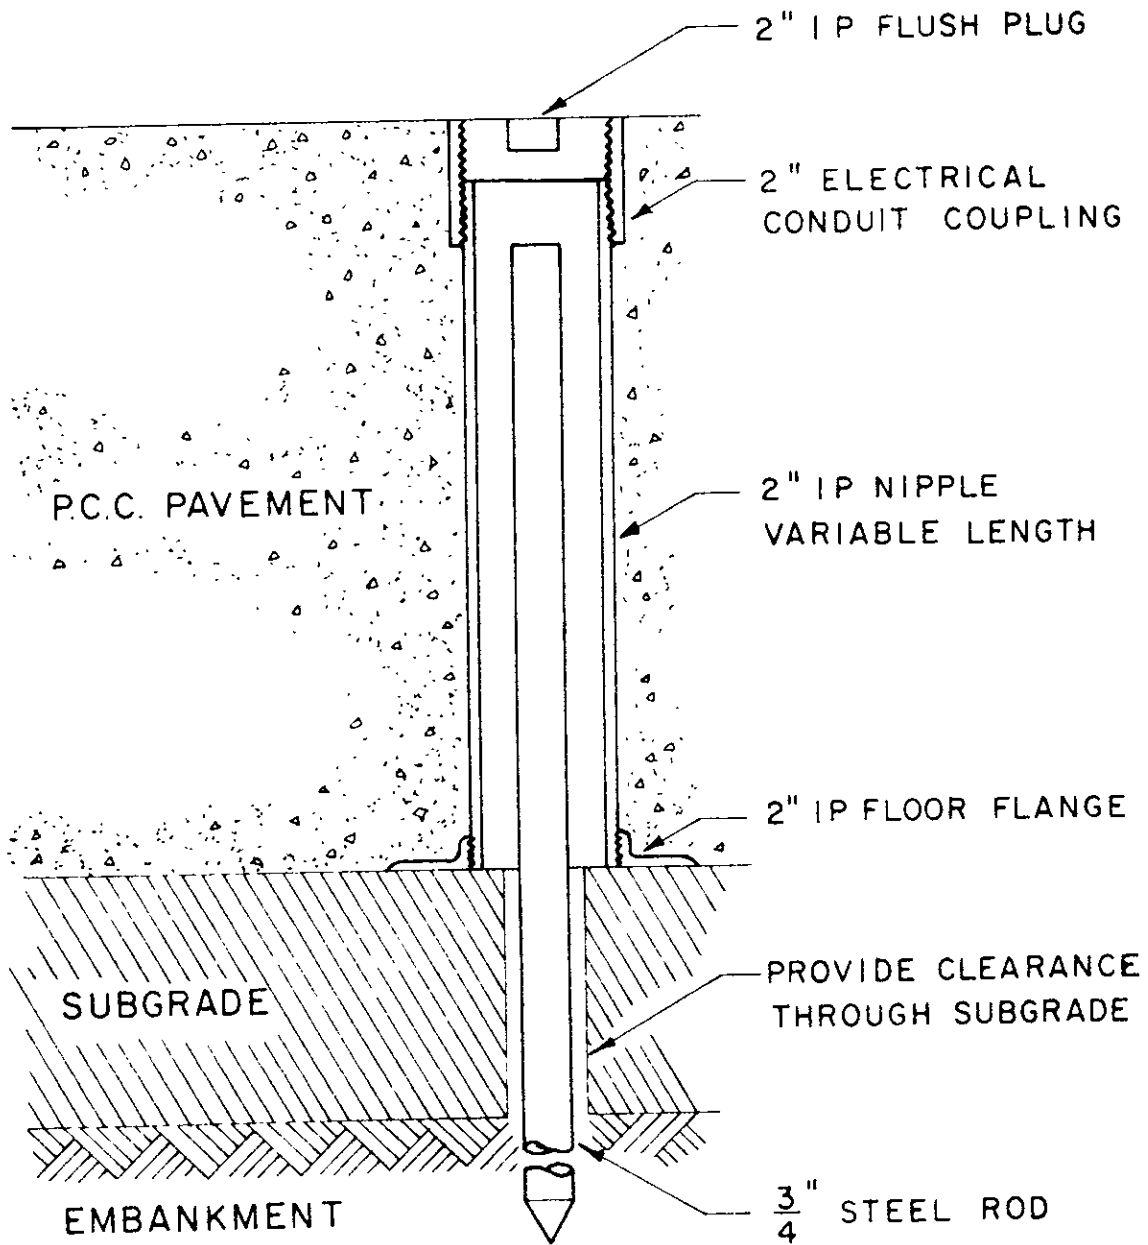
Fig I

The ability of a pavement slab to span areas of nonsupport cannot be appraised where settlement of the underlying support does not occur, i.e., where the support remains in full contact with the slab. To reveal the separation between the pavement and the subgrade devices of the type illustrated in Figure I were placed in each of the special design slabs. The initial elevations of the pavement surface and the top of the center steel rod, and the differential between these values is determined at the time of placement. Comparison with the differentials determined by periodic check readings throughout the life of the project reveals the magnitude of the separation.

## SUBGRADE SETTLEMENT DEVICE

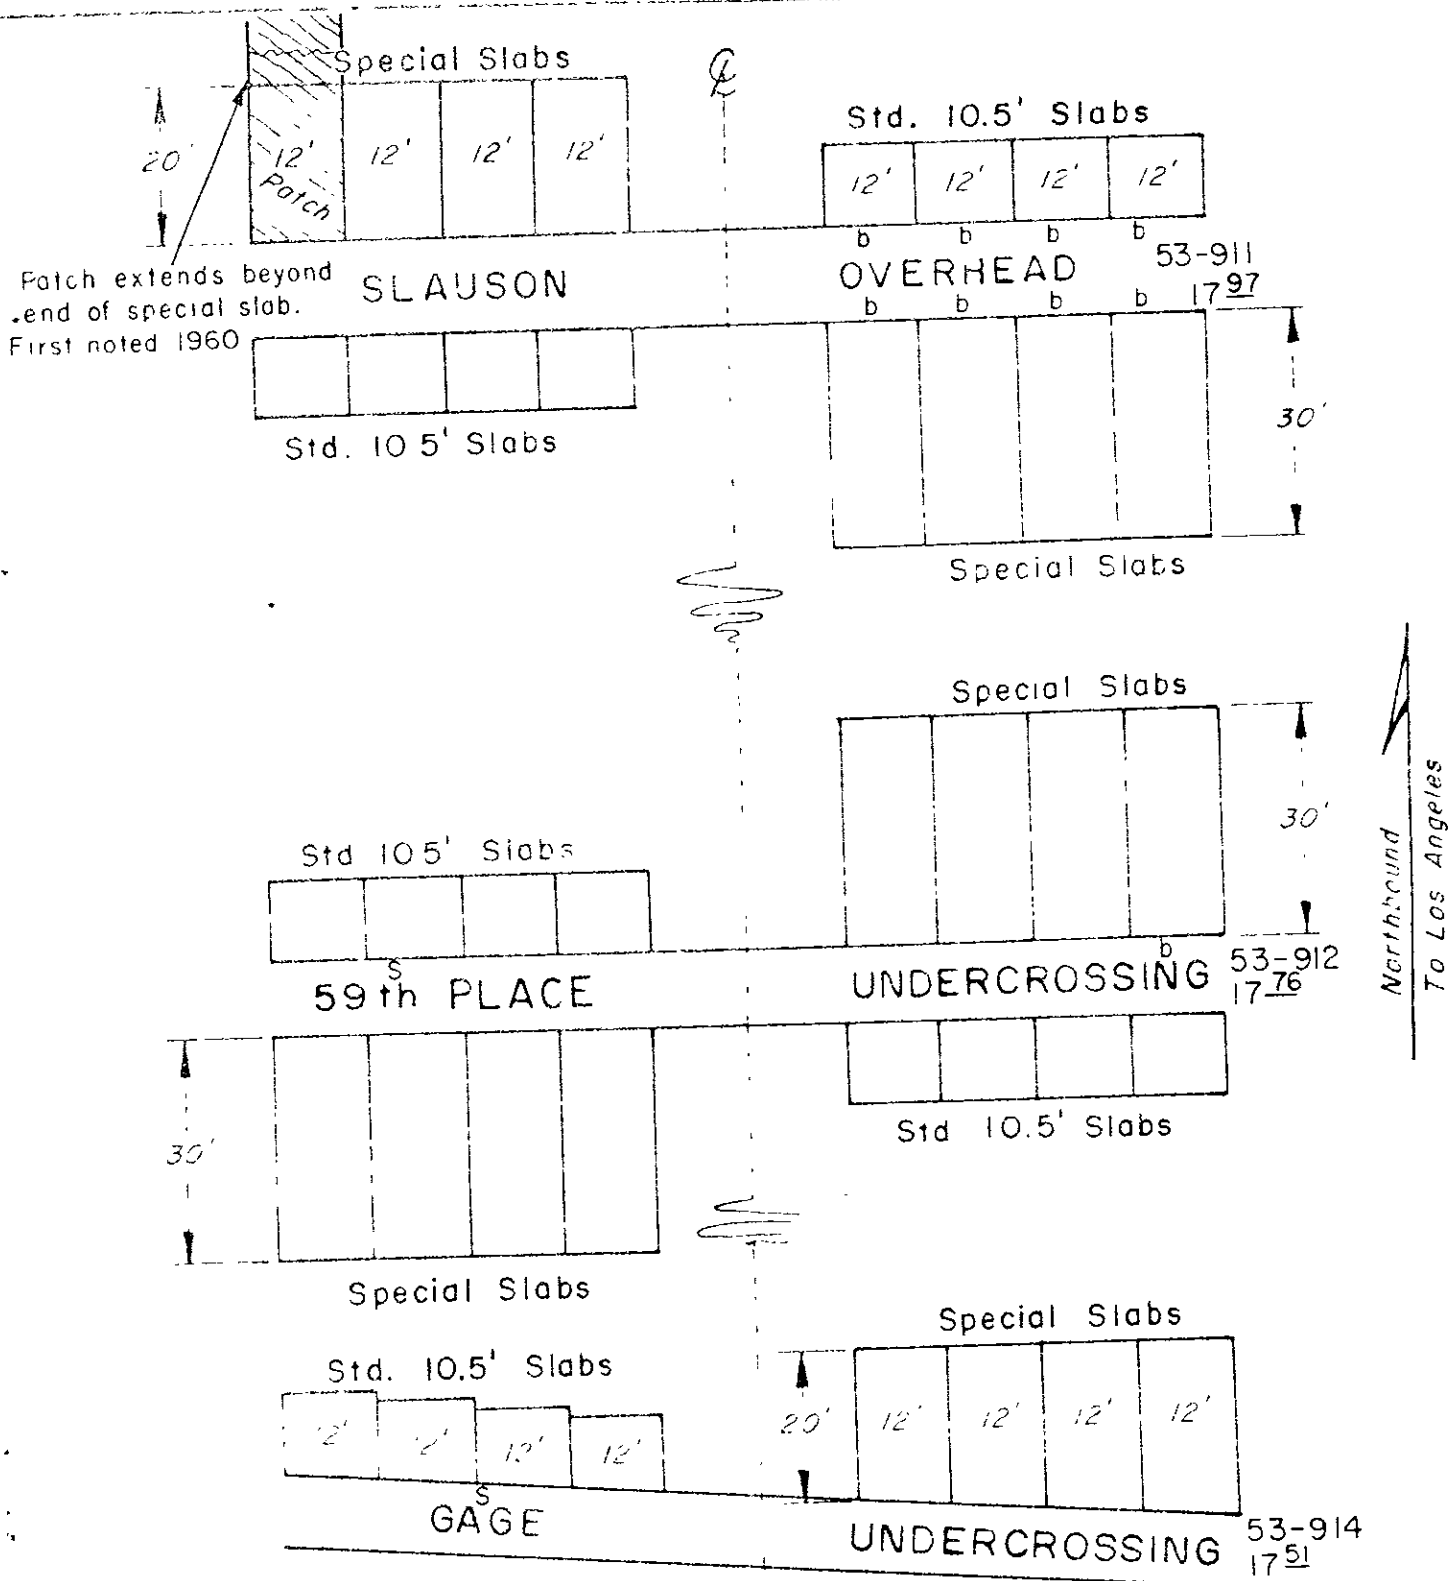
FIG. IV

The three special study locations on the Harbor Freeway are sketched in Figure IV. Completion date for the contract was May 16, 1957. Inspection periods at these locations coincided with those on the San Bernardino Freeway, i.e., July 1958, July 1960, March 1961, and with similar findings. Except for a patched area on the special design slab at Slauson Avenue Overhead, as marked in Figure IV, both special and standard slabs remain free of visually discernible distress. The patch at Slauson Avenue O.H. was placed between the times of the July 1958 and July 1960 inspections, and is at a location where a large volume of truck traffic uses the off ramp to reach the nearby industrial area. This patch extends completely over the ramp lane as well as the outside travel lane.

While there has occurred minor cracking and other defects as noted in Figures III and IV, there are only two instances of patching, one on each of the freeways. One patch appears on a standard slab and one on a special slab. There are no indications of mudjacking or other major maintenance operations.

## MATERIALS AND RESEARCH DEPARTMENT INVESTIGATION of EXPERIMENTAL BRIDGE APPROACH SLABS HARBOR FREEWAY
